UM-3703-98 1998 Chevrolet Cavalier

In-depth Vehicle Occupant Report

The University
of Michigan
Transportation
Research Institute

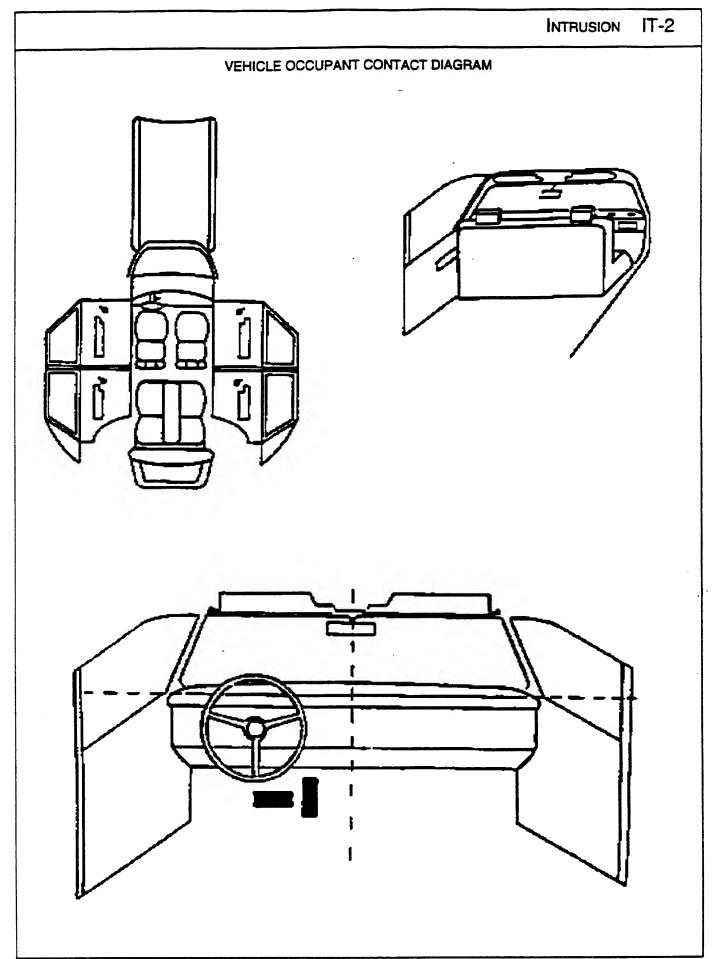
İNTRU	SION IT-1
Location of Intrusion	of 1	Intruded	Component	Compar Value	(All Measurements Are in ison _ Intruded e — Value	Centimeters) = Intrusion	Dominant Crush Direction
13		POOR			64- 56	= 14	Y
13		B-pil	lan		6.8 - 50	= 18	Y
13		RSR			44 -40	= 4	Y
13		sill			63 - 51	= 12	Y
						=	
23		Poor	l		63 - 51	= 12	Y
		R 51			44 - 4/	= 3	4
23 23		5:11			63 - 51	= 12	4
					-	=	
					-	=	
					-	=	
					_	=	
					_	=	
					_	=	
					_	=	
					_	=	
			0	CCUPANT C	CONTACT WORKSHE	ET	
Contact	Co	Interior Imponent Intacted	Occupant No. if Known	Body Region if Known	Supporting F	Physical Evidence	Confidence Level of Contact Point
Α							
В							
С							
D							
E						·	
F							
G							
н							
l							
J

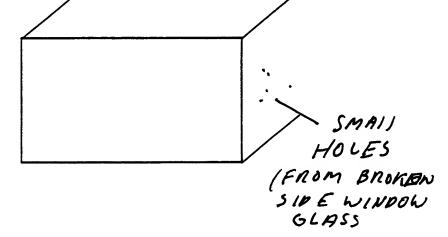
AIR DAG 38 WIDE 52 TALL
